## **On the weldability and corrosion resistance of alloy UNS N08827 – a further improvement of alloy UNS N08825**

Julia Botinha  
VDM Metals International GmbH  
Kleffstraße 23  
Altena, 58762  
Germany

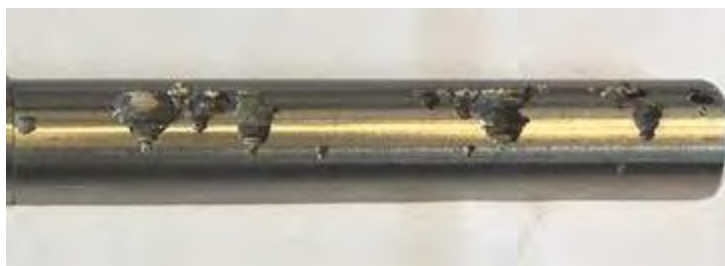
Although the pitting corrosion has mostly initiated in the weld seam, as shown by Figure 4, the temperature at which it starts being observed is similar to the ones observed for the base material and therefore we can conclude that there is no detrimental effect of the welding process in the pitting corrosion resistance of UNS N08827.

**Figure 4: Sample of welded tube tested according to ASTM G48 Method C at 55 °C, after pitting corrosion took place in the surface of the sample**

The results of the ASTM G48 C test carried out in the sample of welded tube are shown on Table 4. The CTP determined for the welded tube sample of alloy 825 CTP is 55 °C and it is defined as being the minimum temperature to produce pitting attack on the surface of the specimen.

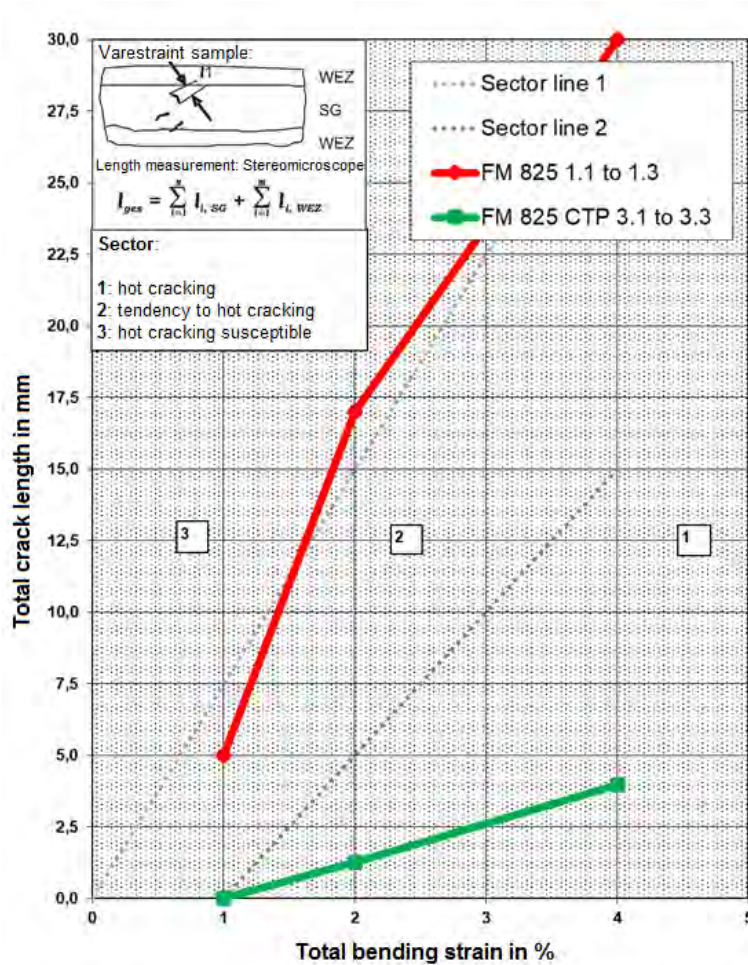
Samples of both welded metal UNS N08825 (FM 825) and N08827 (FM 825 CTP) were investigated through MVT tests to assess their susceptibility to hot cracking. After welding, the total crack length of each sample was calculated and plotted on the diagram shown on Figure 6.

The results show that, as expected by the calculated solidification intervals, FM 825 CTP presents much less cracks after welding in comparison to FM 825. As it can be seen, the diagram of Figure 6 can be divided in 3 sectors, each indicating a different behavior to hot cracking while/after welding: 1) hot crack safe, 2) with increasing tendency to hot cracking and 3) vulnerable to cracking.

FM 825 CTP finds itself in the sector 1, which indicates that the filler metal is hot crack safe, while FM 825 finds itself right over the line that divides both sectors 2 and 3, indicating that this filler metal has an increased tendency to hot cracking or might be vulnerable to cracking.

**Figure 6: Influence of the bending strain in the total crack length of the weld metal samples of FM 825 CTP and FM 825. Sector 1 means hot crack safe, sector 2 means with increasing tendency to cracking and sector 3 means vulnerable to cracking**

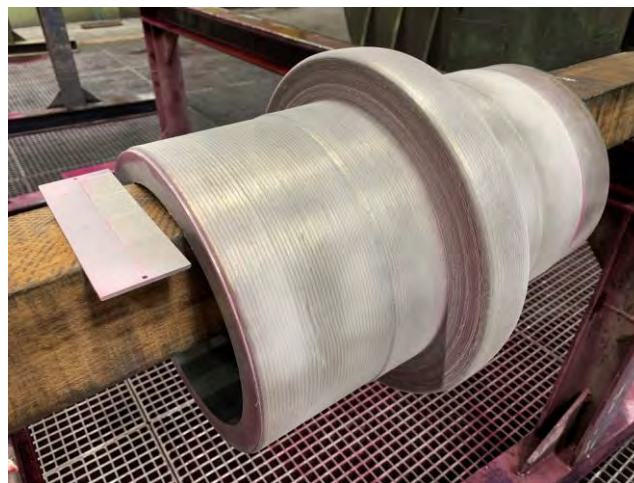
Figure 7 shows the mock-up overlay weldment during the dye penetration testing according to DIN EN ISO 3452. The dye penetration test indicated no cracks or other notable flaws like pores or lack of fusion (LoF).

**Figure 7: Mock-up overlay welding of a tube**
